**BATTERY ANOMALY INVESTIGATION
SATELLITES 9437 AND 9438**

TRW DEFENSE AND SPACE SYSTEMS GROUP
ONE SPACE PARK
REDONDO BEACH, CALIFORNIA 90278
REPORT NO. 32824-AR-019-01

APRIL 1980

FINAL REPORT

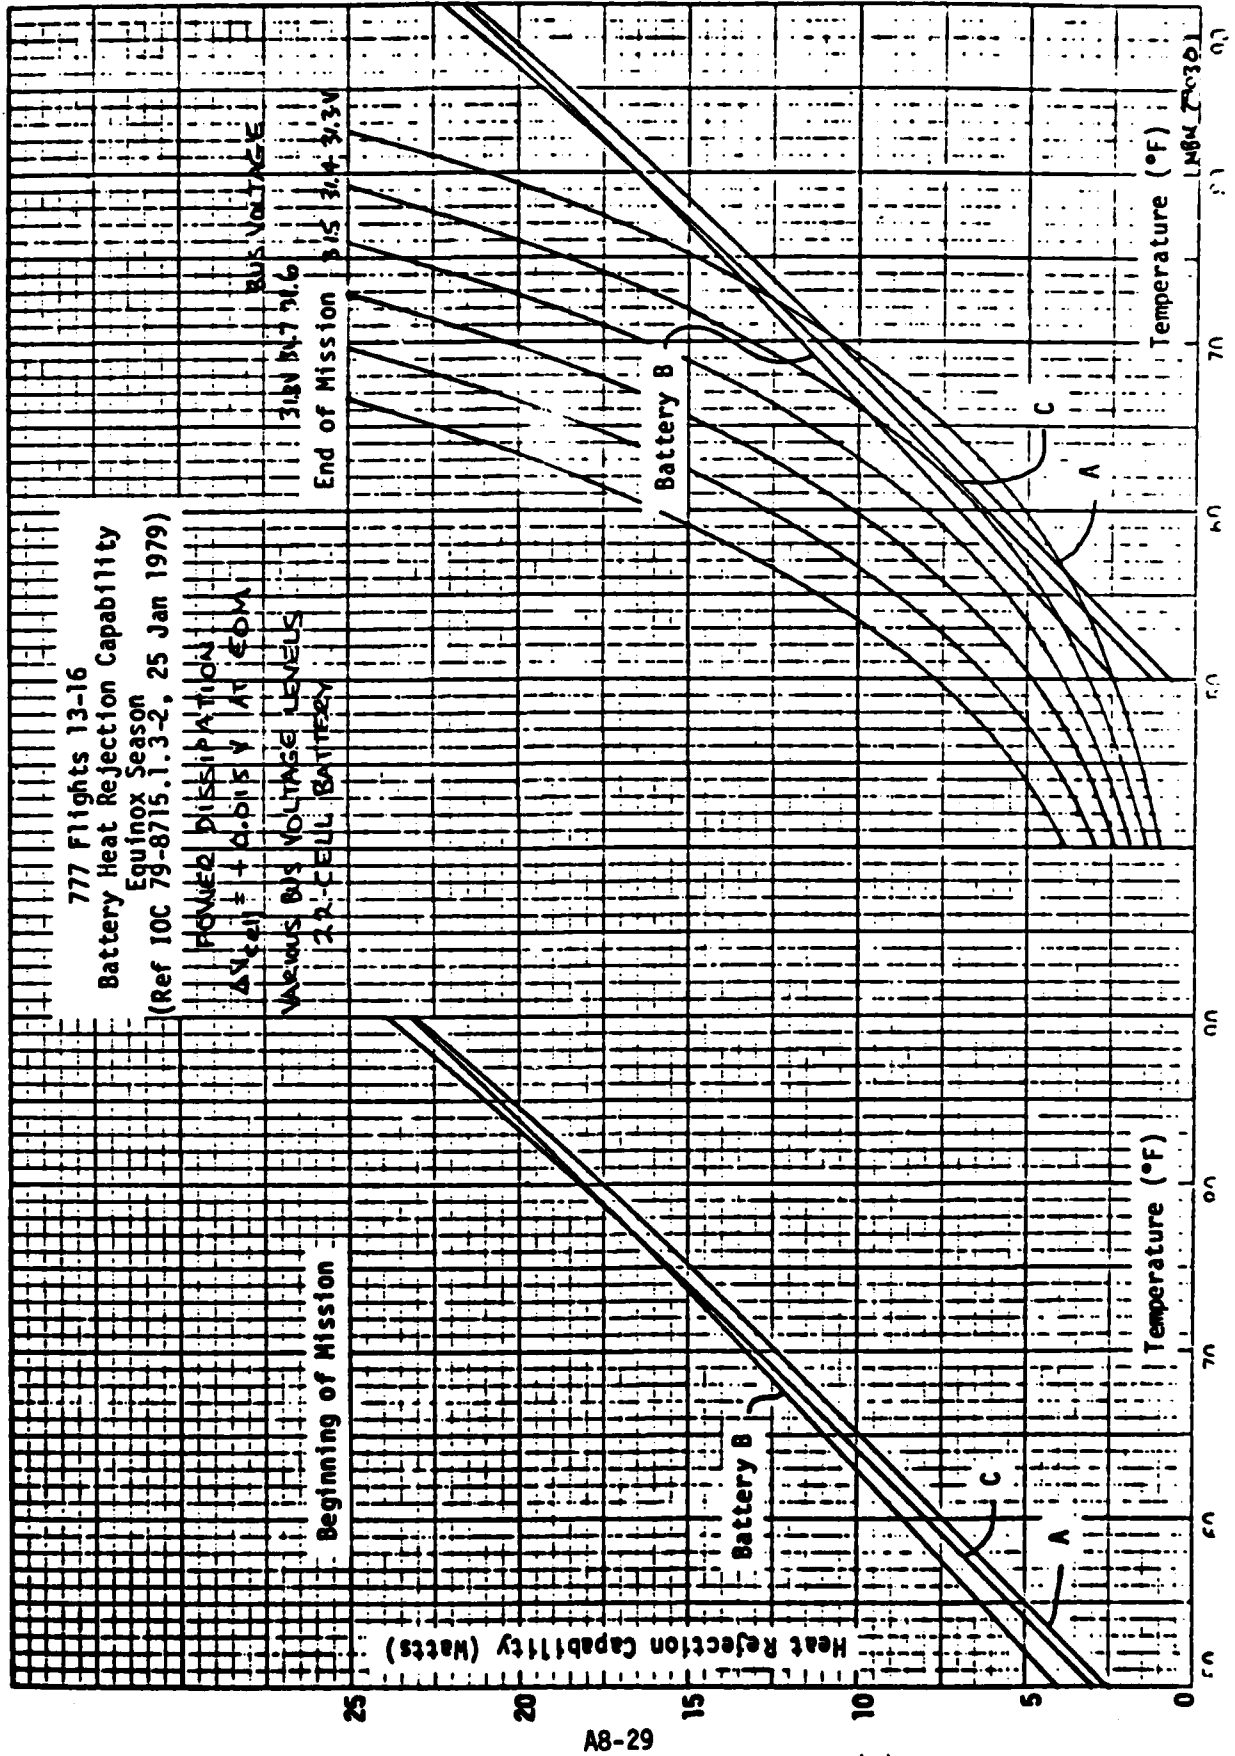
FIGURE 4-5

self-heating of each battery is determined by selecting a dissipation curve on Figure 4-5 which is displaced horizontally from the lowest heat rejection curve (namely battery B) by at least 5°F. The dissipation curve for bus voltage of 31.6 volts just barely meets this criterion. Higher bus voltages meet this criterion by greater margins.

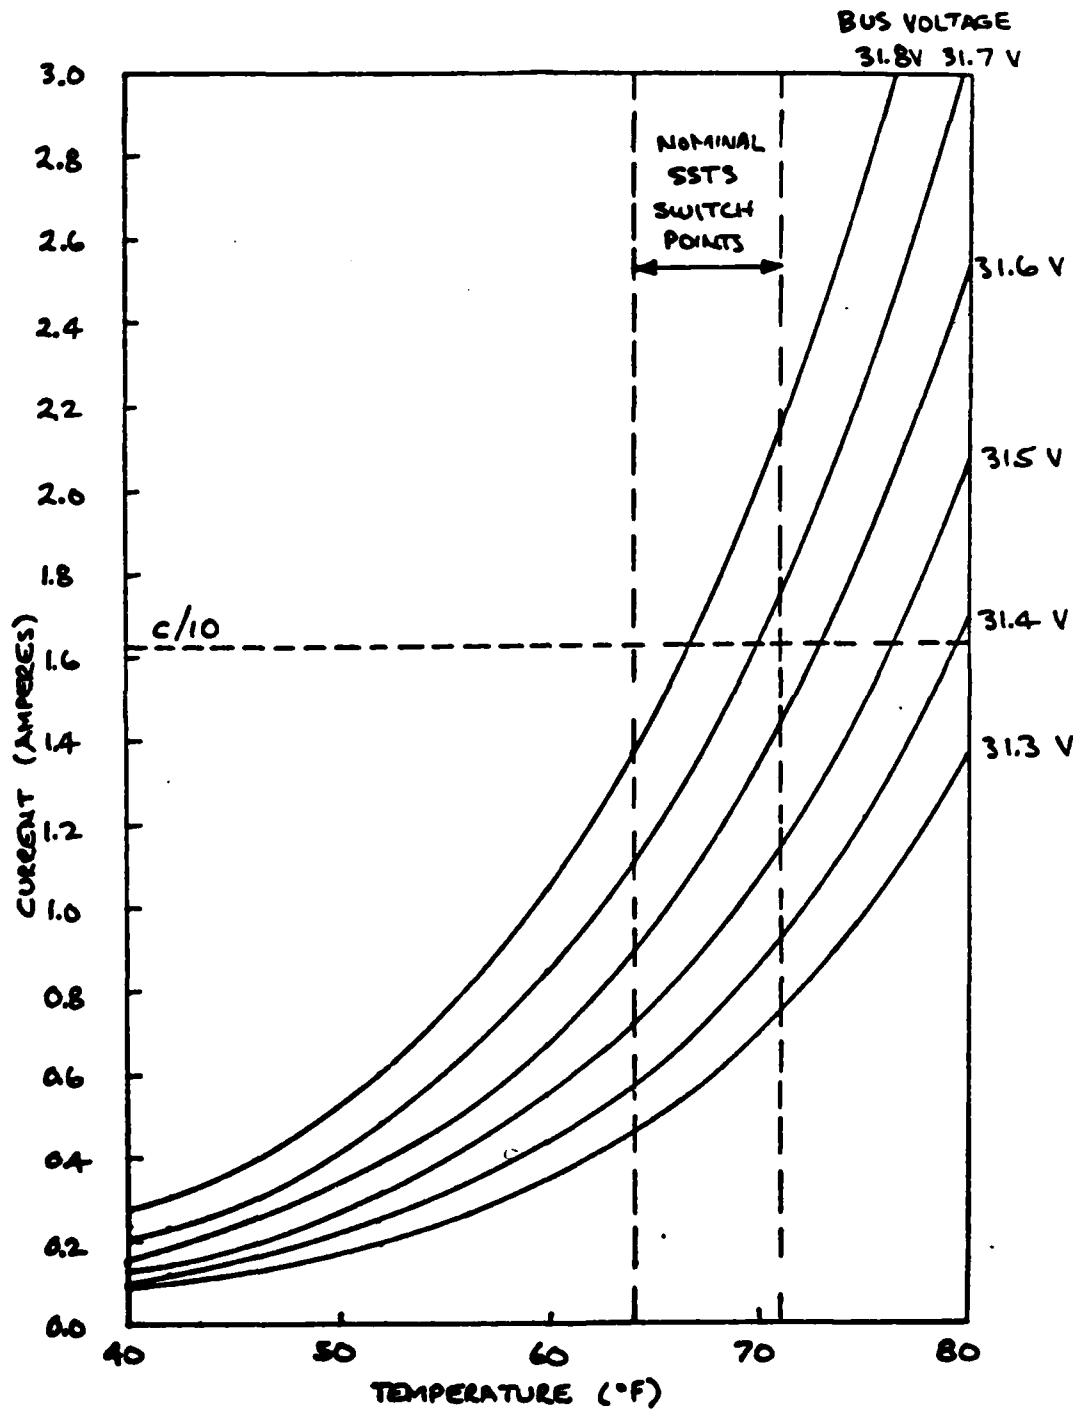
The greatest interest for use of direct connection of a battery to the bus occurs when cell voltage increases during continued recharging, to the point where charging at the high bus voltage of 33.8 volts would conceivably be inadequate. This would be a contingency in which direct bus connection would be used at a lowered bus voltage. Thus the positive variation of cell voltage in overcharge is of no apparent significance for examination of direct bus connection.

FIGURE 4.6. OVERCHARGE CURRENT —
BATTERY CONNECTED DIRECTLY TO BUS (CELL
VOLTAGE UNCERTAINTY 0.005 V/CELL RE TAPEL CURVES)

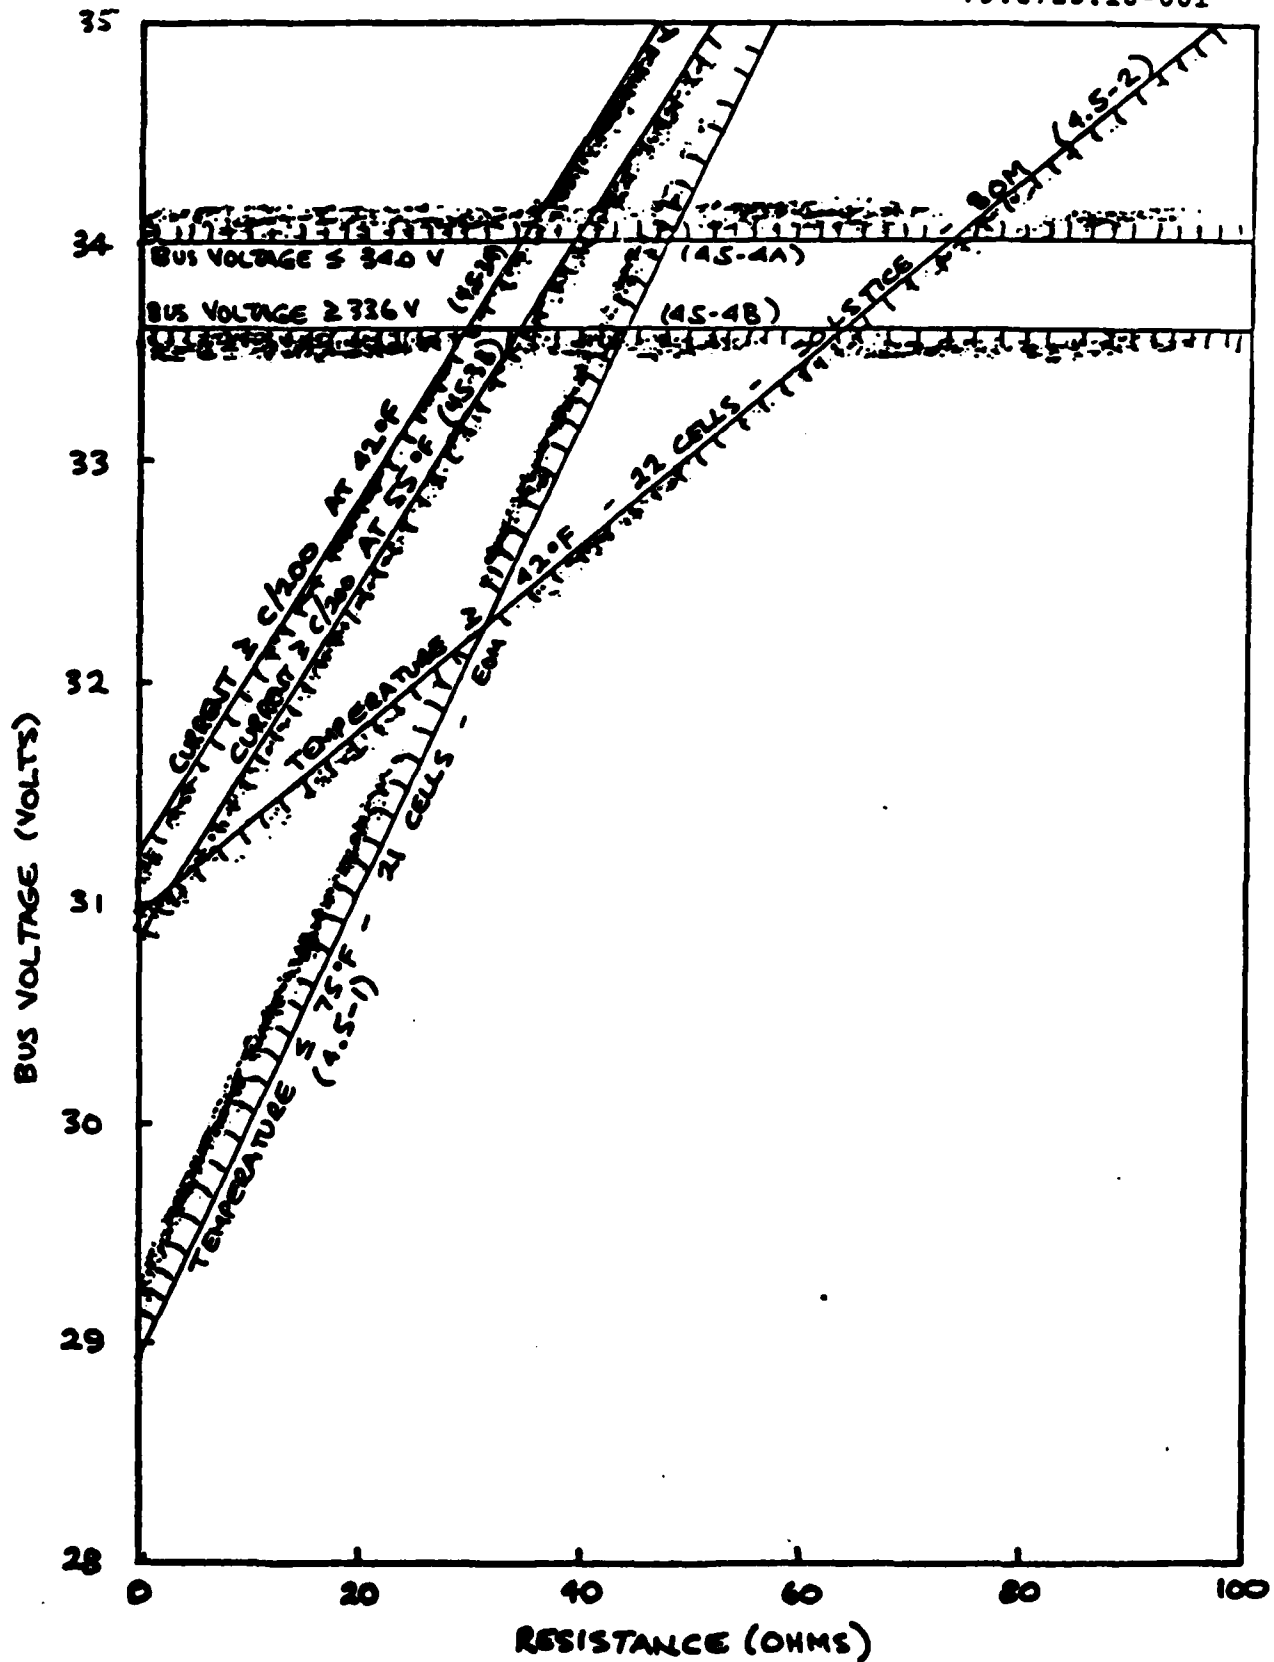
The bands of operating temperatures are summarized in Table 4-1 for the aggregate of three batteries with combinations of worst-case cell voltage uncertainty, together with the associated overcharge current ranges.

FIGURE 4-11. CONSTRAINTS ON BATTERY ISOLATION RESISTANCE
